Test Report No. 7191147996-MEC16/03-SL
dated 29 NOV 2016

Load test for Rotule & Spider

Ocius Hardware
Jakarta, Indonesia

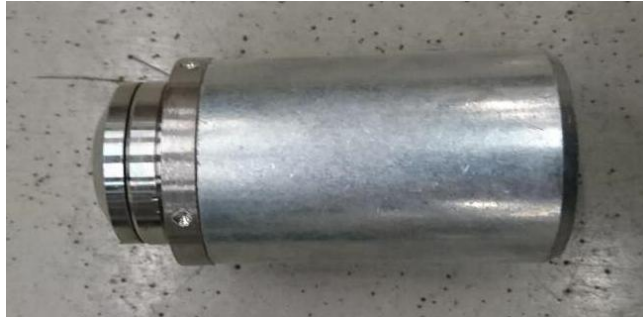
Photo. 1 : Rotule

2 pieces of stainless steel spider fitting brand "OCIUS"
2 pieces of rotule

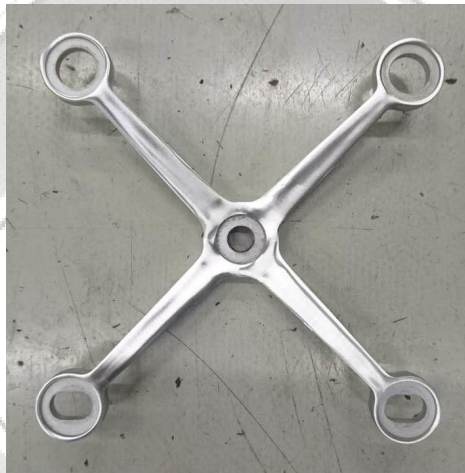
Photo. 2 : Spider fitting

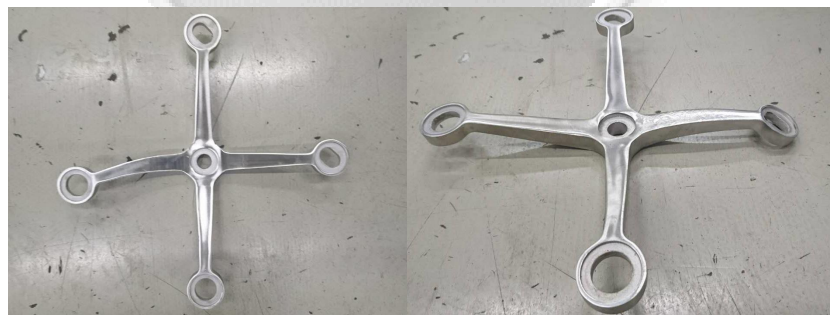
Photo. 6: Mode of failure - Spider fitting

Sample reference	Radial	Axial
Maximum force (kN)	6.3 (642.6 kgf)	6.4 (652.8 kgf)
Mode of failure	Spider fixing deform
